NONDESTRUCTIVE EVALUATION OF METAL MATRIX COMPOSITES.(U)

MAY 82 S W SCHRAMM, I M DANIEL

NONDESTRUCTIVE EVALUATION OF METAL MATRIX COMPOSITES

FINAL REPORT

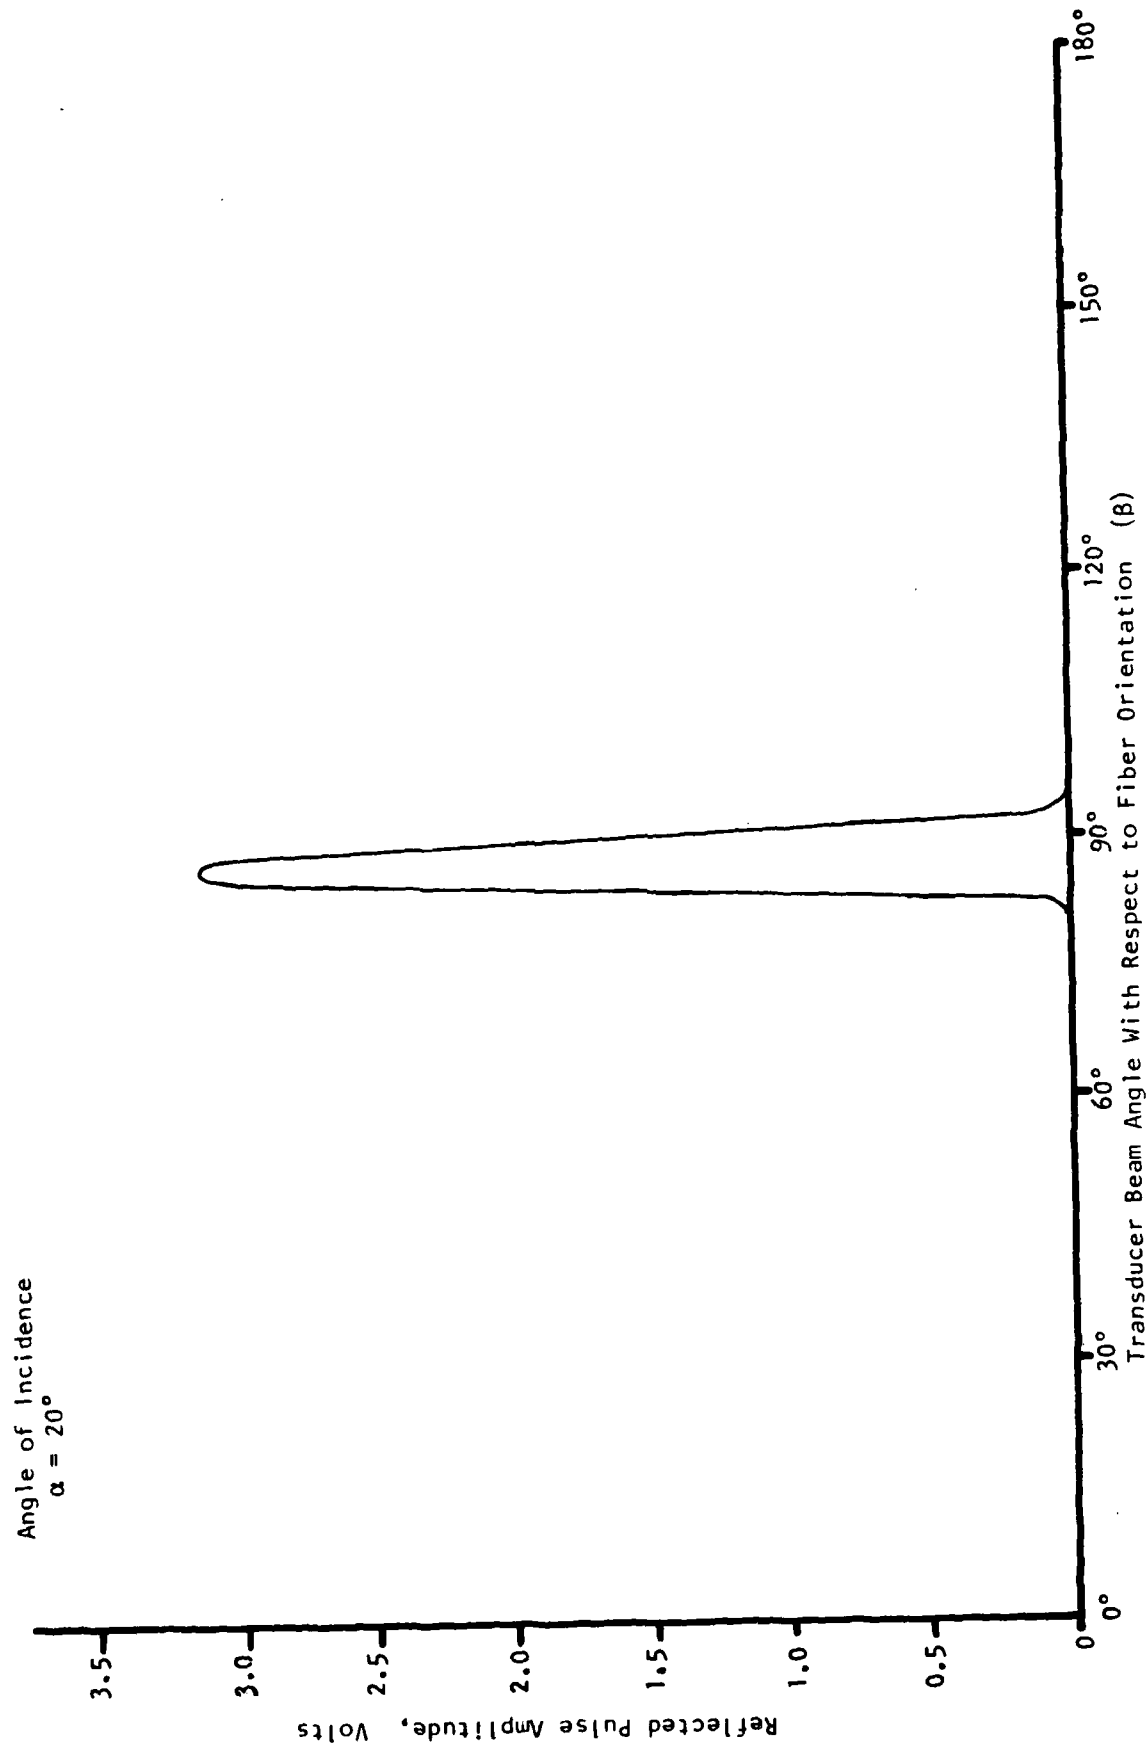
Figure 26 is a characteristic backscatter curve of Specimen 1-1. The incident angle (α) of the 5 MHz immersion transducer operated in the pulse-echo mode was 20° with respect to a line normal to the front-face surface plane of the specimen. The curve shows activity only as the focal axis of the transducer sweeps near and through the plane normal to the fiber orientation. Any activity shown away from $\theta = 90^\circ \pm 5^\circ$ would be due to a material defect, since all the specimens, with the exception of Type 4, had a uniaxial fiber orientation. The curve in Figure 26 indicates no material defects in the area of inspection of Specimen 1-1.

Figure 26. Ultrasonic backscattering curve of FP/Mg specimen with no intentional flaws (Specimen 1-1).

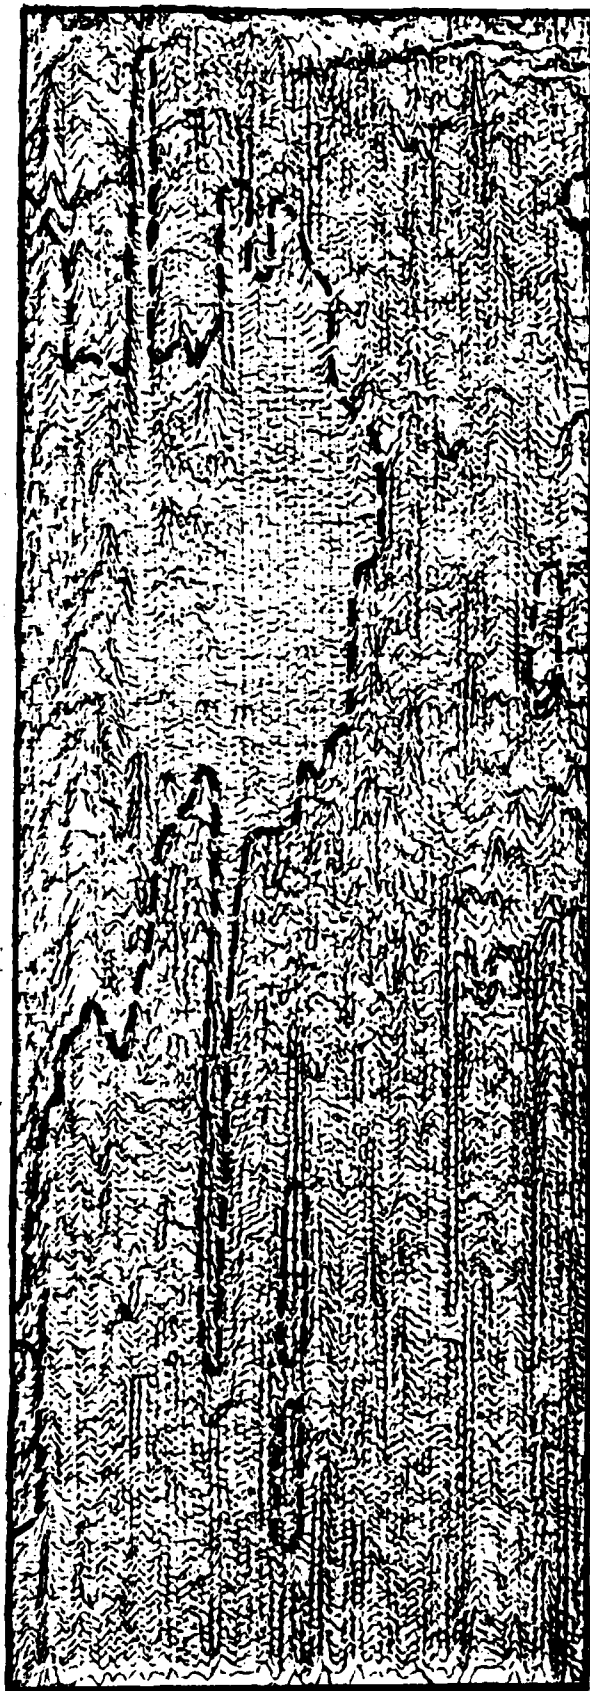
Both C-scans show a well-defined area of apparently flawed material involving approximately 20% of the specimen. The narrow bands of apparent damage running parallel to the fiber direction were identified as surface scratches by A-scan interpretation and visual inspection.

Figure 37. Analog C-scan of FP/Mg Specimen 3-1 (porosity),
15 MHz transducer in pulse-echo mode.

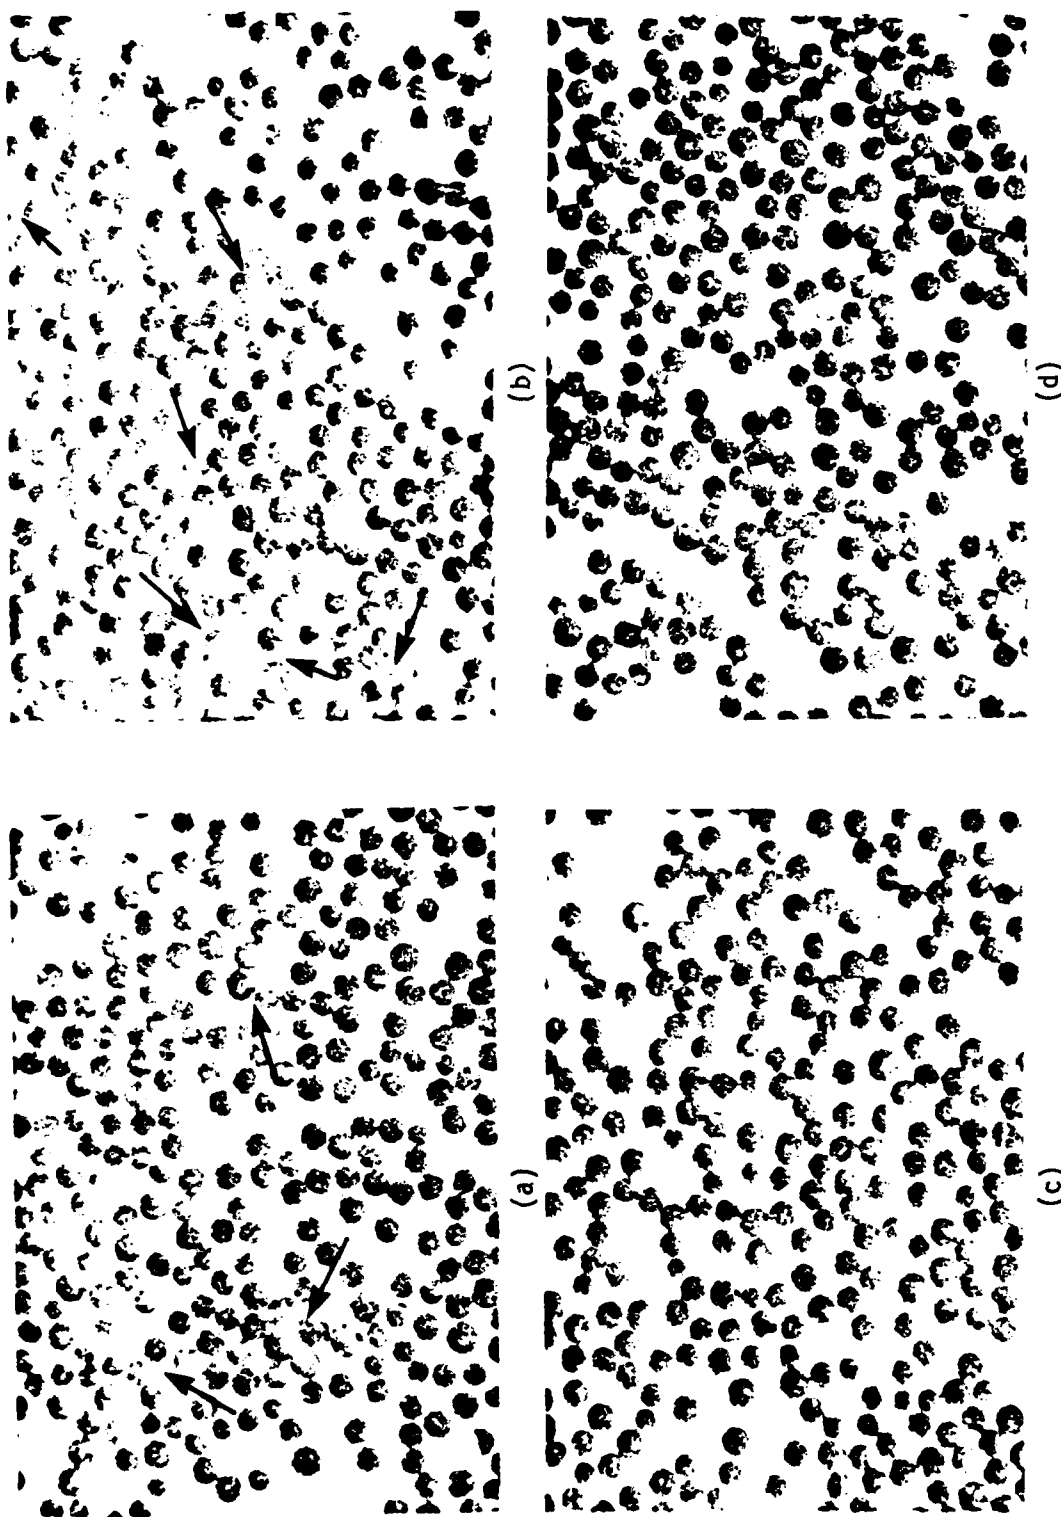
Figure 71. Micrographs (200X) of FP/Mg Specimen 7-2 (matrix fracture) at four section locations:
 (a) Location 7-2-1, (b) Location 7-2-2, (c) Location 7-2-3, and (d) Location 7-2-4.
